Service Bulletin

Document Number: **SB 2020/01**

Topic: Firmware version 1.0.12 released
Applies To: Falcon 360 Tracking System
Serial Numbers: 00100 and above
Release Status: Required for continued Warranty conditions of Falcon systems

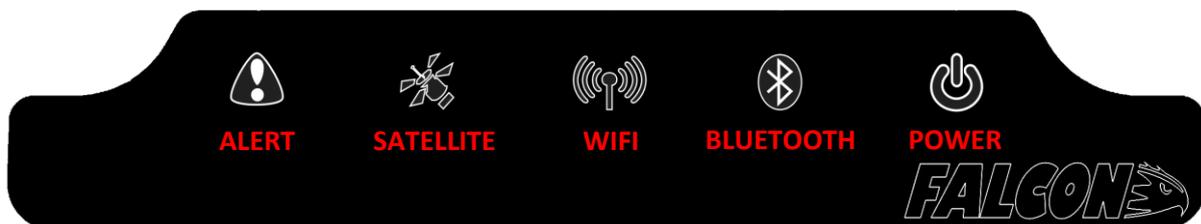
Please refer to the above button layout - once powered on, look for the following phases of operation:

- a) Insert the prepared USB flash drive into the unpowered Falcon
- b) Power on the Falcon system and ensure that it will remain adequately powered for at least 6 minutes.
- c) About 14s after power on, all front lights will briefly flash **WHITE**, and then the Power light will flash **WHITE**.
- d) After approximately 20s the Satellite light should start flashing **YELLOW** – this indicates that the Falcon has identified the USB drive and will start executing the instructions encoded on it.
- e) This process finishes after about 30 seconds since power up, and the Falcon will switch all front lights to **GREEN** to indicate completion.
- f) The Falcon will then reboot to start using the new Falcon firmware.
